# **Cobden wetlands inanga habitat assessment and recommendations for future management**

Mike Hickford and Shane Orchard  
Marine Ecology Research Group  
University of Canterbury  
May 2017.

This short report describes an assessment of the Cobden river floodplain area and Aromahana Lagoon shoreline, carried out in the company of Henk Stengs, Ranger, Department of Conservation, Greymouth on 1 and 2 May 2017.

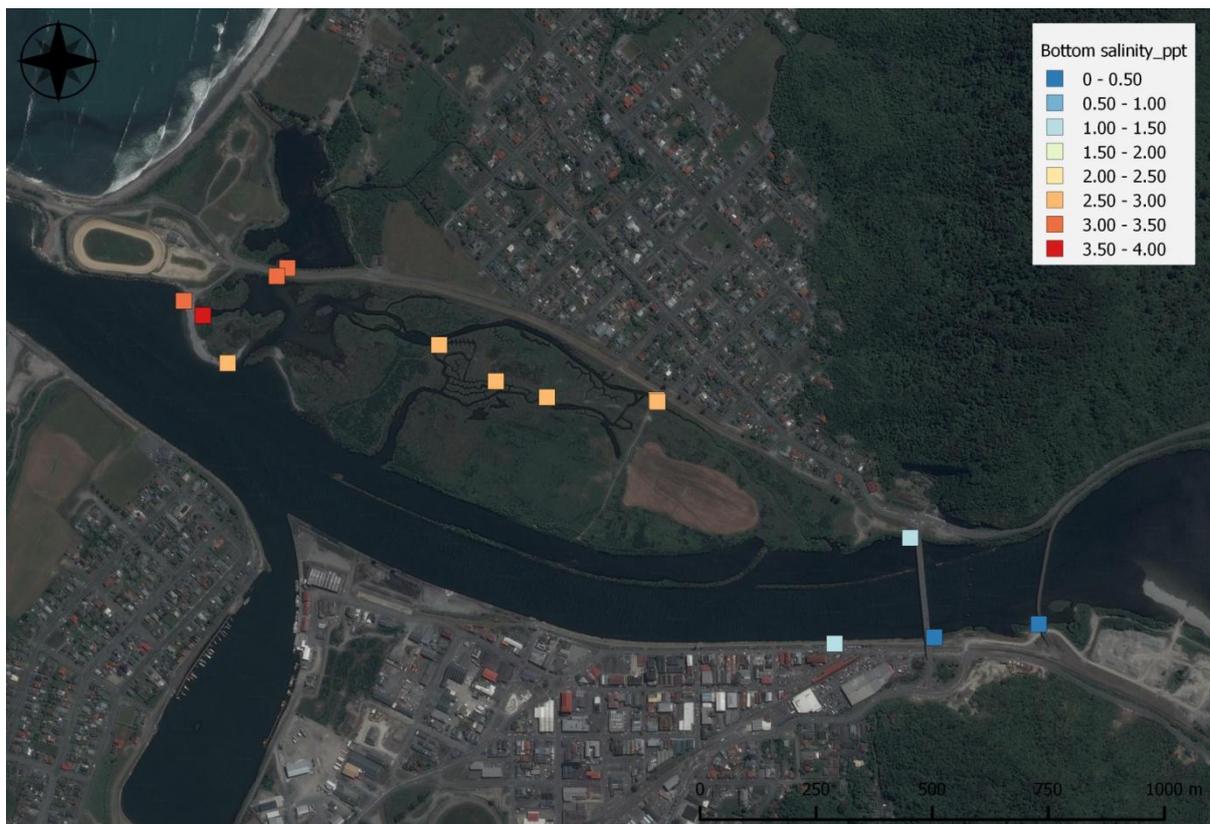
18. Salinity is within the range suitable for inanga spawning (Figure 1).

**Figure 1.** Bottom (maximum) salinity measurements recorded 1 May 2017 on the tidal peak (3.2m high tide @ 3.11pm)

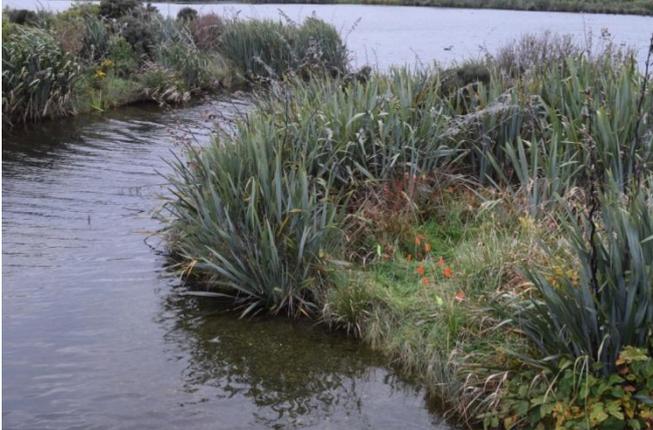
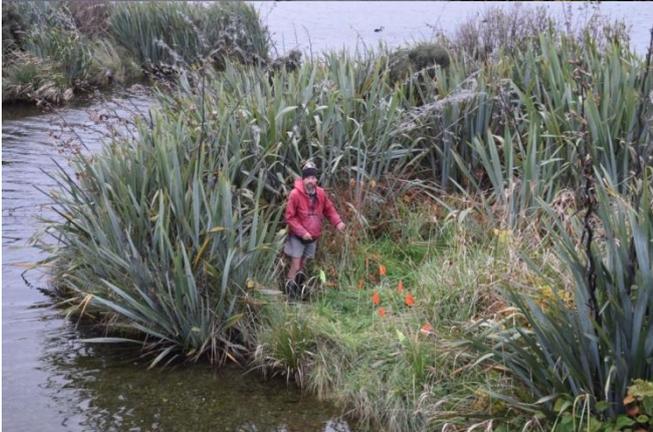
Site 1

Eggs were found immediately upstream of its outlet under the road, on both left and right banks. These are new records and although small in area are likely to see repeat use. They will be also be good demonstration sites to engage the public and should be monitored to ensure the condition of the vegetation is suitable. A search along the west side of Cobden Lagoon, where there have been reports of spawning in the past, yielded no eggs. That may have been because the vegetation was in poor condition due to having been trimmed and through application of herbicide.
